COUNTIES (MD/PA) CARROLL/YORK

M&D milestone no. 59 (62)

MHT-HSI no. CARR-295

FIELD SHEET: MASON & DIXON LINE, MARYLAND-PENNSYLVANIA BOUNDARY MARKER SURVEY

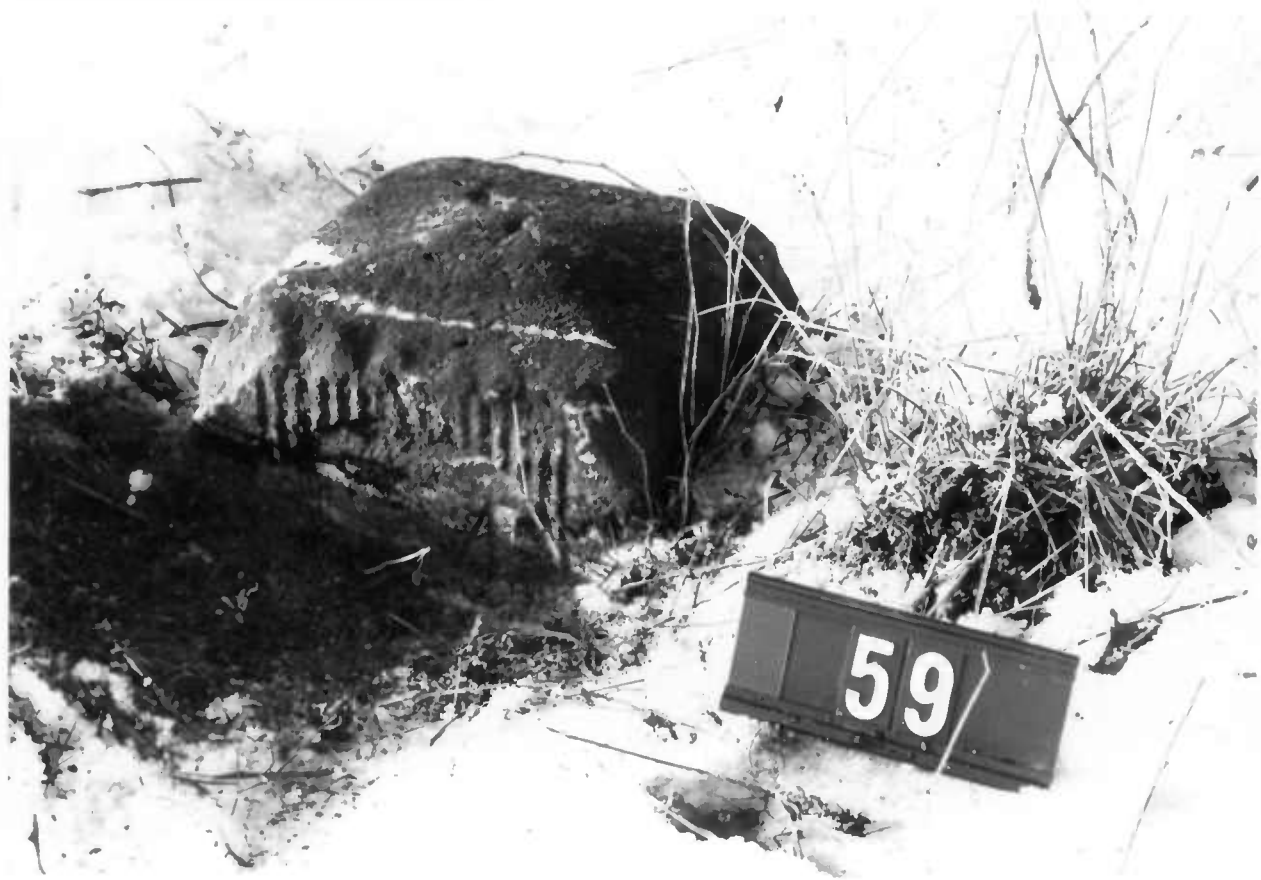
1979-80 Inspection notes: order no. 59 (62); photos/negatives/slides no. 59 (62)  
59 (62). Original M&D monument of 1766 in place though half-buried by soil, in  
fairly good condition, firmly set. Lettering clear & intact, most fluting  
remains, all surfaces weatherworn. Endangered by farm machinery.

MASON & DIXON WEST LINE: MILESTONE NO. 59 (CARROLL COUNTY)

VIEW OF NORTH (PA.) & WEST FACES, & TOP

This stone is in an out-of-the-way site, but easily chipped by farm machinery. It should be exposed another 6" & witness post erected, to serve notice to any farmers working these fields. Property owners should be notified, & Robert Steger family (who so kindly sent their children along to show us the way).

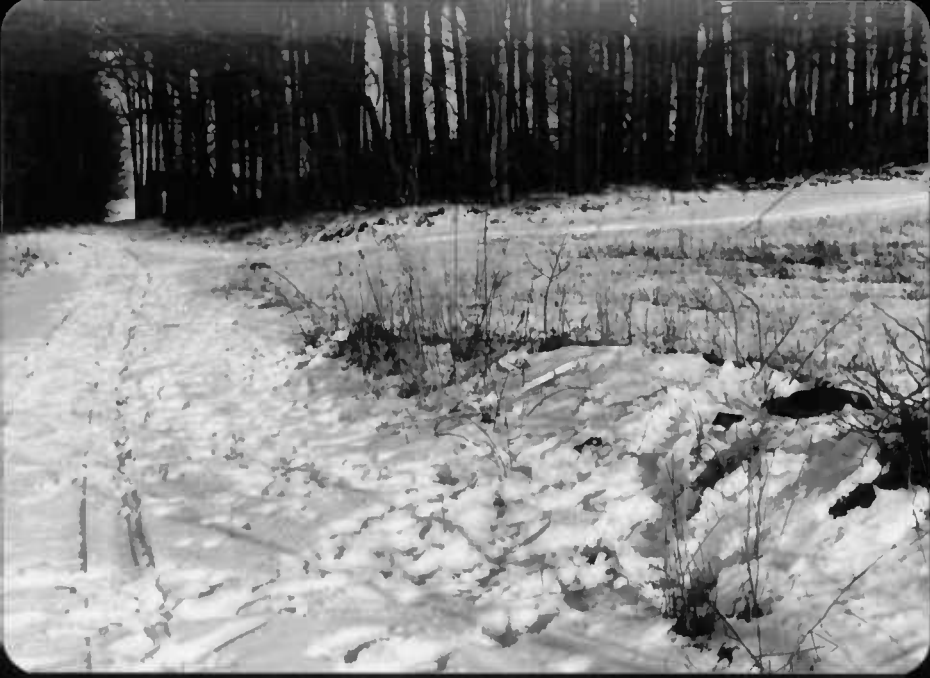
MASON & DIXON WEST LINE: MILESTONE NO. 59 (CARROLL CO.)  
RYS MT. VENTUS RD. NO. 2, WEST MANHEIM VICINITY  
VIEW OF SE CORNER & TOP

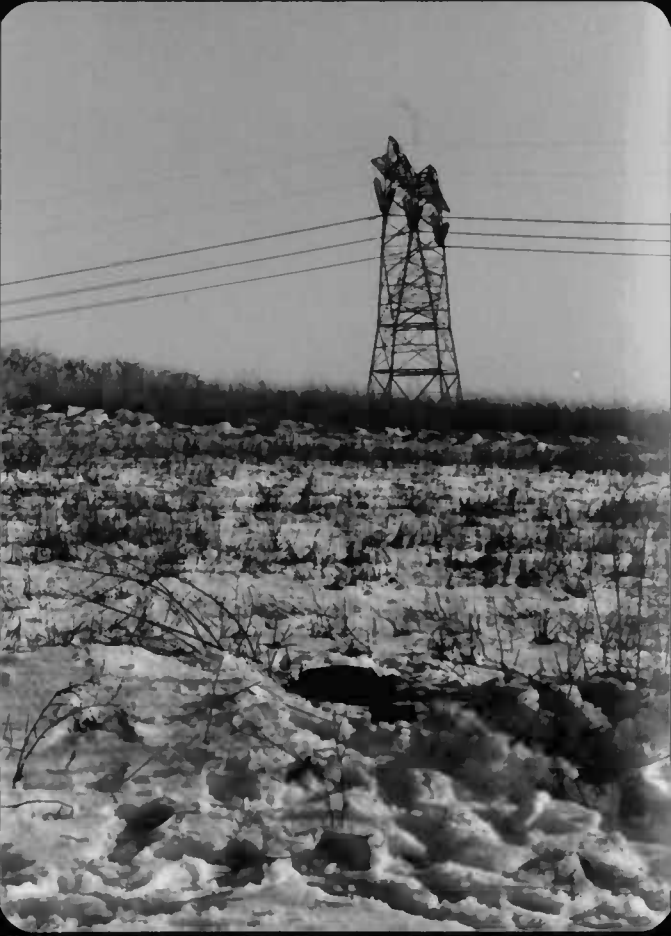
MASON & DIXON WEST LINE: MILESTONE NO. 59  
LOOKING DUE EAST ALONG FARM LANE (2  
M/D LINE) LEADING TO MT. VENTOS ROAD (RD)  
NO. 2 JUST NORTH OF ROBERT STEGER  
HOUSE
